# Manhole Inspection Summary

Manhole # S09II1005MH

Insp Date: **1/12/09 3:08 PM**

**Location** Address: **3807 BEEHLER AVE**

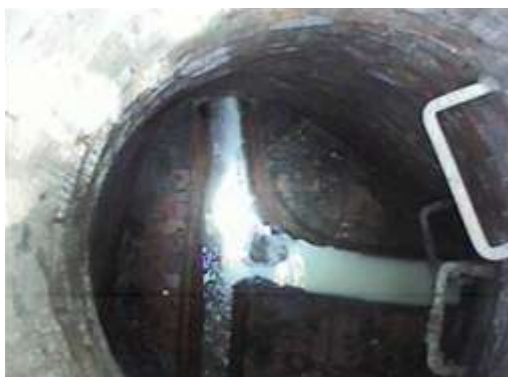
Top View

DEBRIS ON BENCH

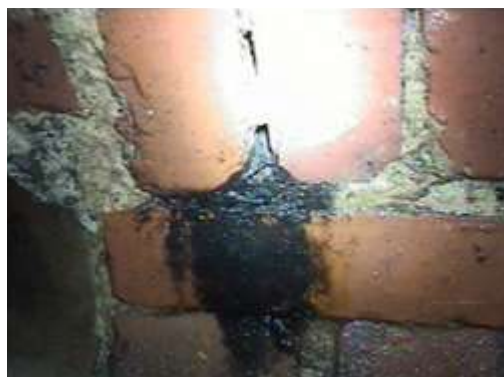
Defect 1

Condition: ☐ Sound ☐ Cracked ☐ Root Intrusion ☐ Deteriorated ☒ **Leaks** ☐ Debris

POSSIBLE INFILTRATION WEEPER  
AND LEAKS IN CHANNEL

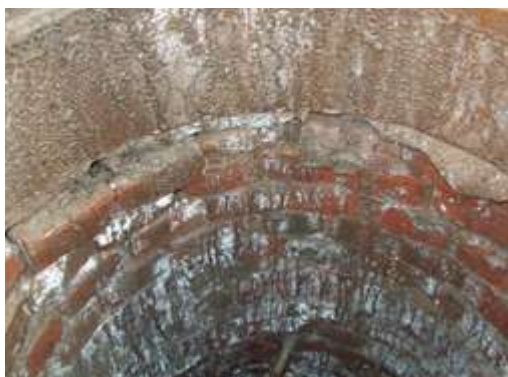
Defect 6

Condition: ☐ Sound ☐ Cracked ☐ Root Intrusion ☒ **Loose Brick** ☐ Deteriorated

LOOSE BRICKS IN CORBEL

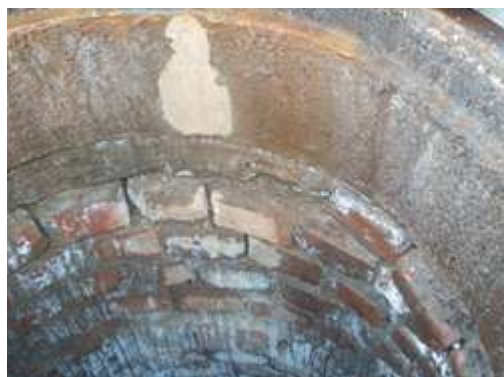
Defect 5

Infiltration: ☐ None ☐ Joint ☐ Cracks ☐ Mortar ☐ Roots ☒ **Wall**

INFILTRATION ON CORBEL/BARREL

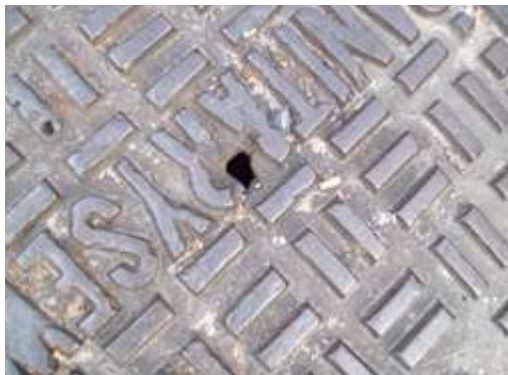
### Defect 4

Condition: **Broken**

BROKEN COVER

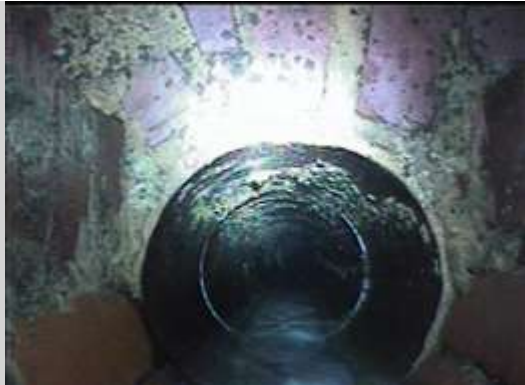
12 O'Clock Outflow

8 in. Circular Gravity Sewer  
Pipe Out @ 12 O'Clock

Pipe Height: **8.4** (in.) Rod and Bar (Angled)  
Pipe Material: **Clay** ☐ Pipe Lined  
Invert Depth: **8.39** (ft.) Flow Characteristics: **Slow**  
Deposits: ☒ None ☐ Mud ☐ Sludge ☐ Debris ☐ Grease  
Silt Depth: (in.) Deposits Extent:  
Infiltration: **None** Pipe Seal Cond: **Sound**

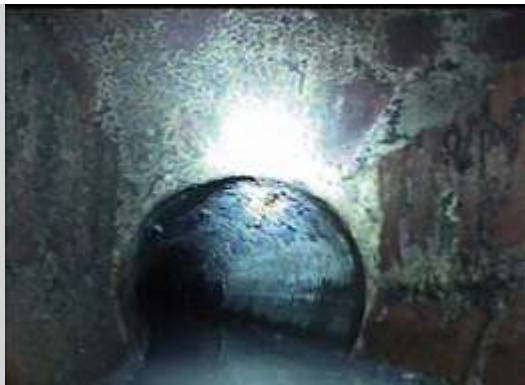
3 O'Clock Inflow

8 in. Circular Gravity Sewer  
Pipe In @ 3 O'Clock

Pipe Height: **8.4** (in.) Rod and Bar (Angled)  
Pipe Material: **Clay** ☐ Pipe Lined  
Invert Depth: **8.38** (ft.) Flow Characteristics: **Slow**  
Deposits: ☒ None ☐ Mud ☐ Sludge ☐ Debris ☐ Grease  
Silt Depth: (in.) Deposits Extent:  
Infiltration: **None** Pipe Seal Cond: **Sound**

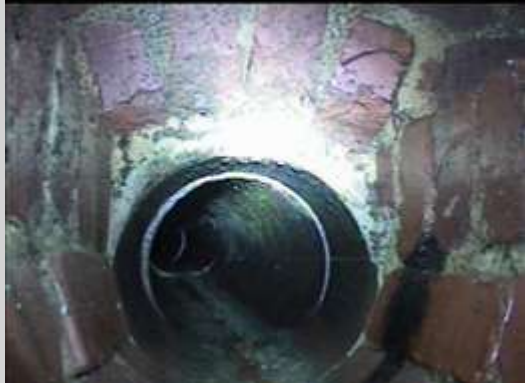
6 O'Clock Inflow

8 in. Circular Gravity Sewer

Pipe In @ 6 O'Clock

Pipe Height: **8.4** (in.) Rod and Bar (Angled)

Infiltration: **None** Pipe Seal Cond: **Sound**
